CITY OF SUMAS: 4635DR-WA Sewer Line Repairs

ADDENDUM #1 issued 03/09/2023

City of Sumas Sewer Line Video Damage Clips and Locations

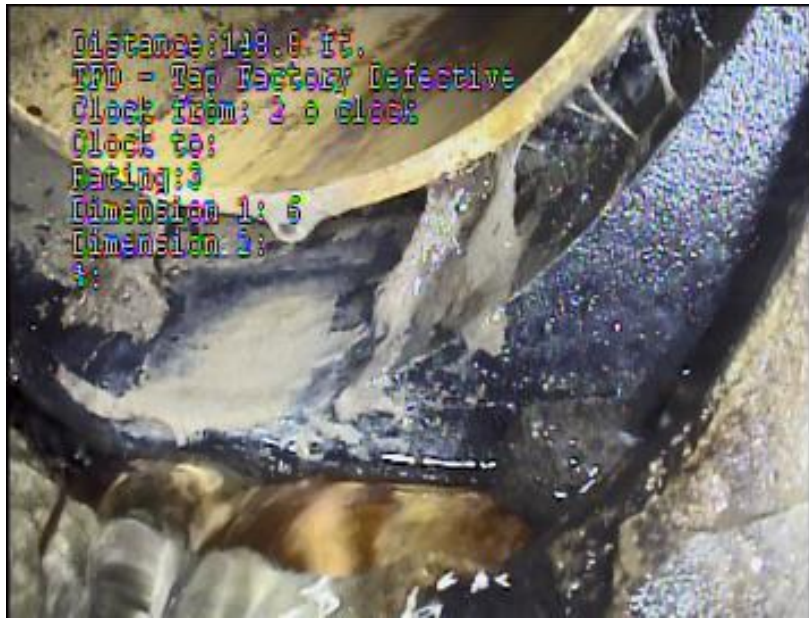
GPS location: (48.993183, -122.261340)

SITE 1: Separation of **PVC pipe (3 inch)** from main **Asbestos Cement Sewer Pipe (8 inch)** connection between Lawson St SSMH-2A and Lawson St SSMH-2. The separation is 148.8 feet east of SSMH-2A.

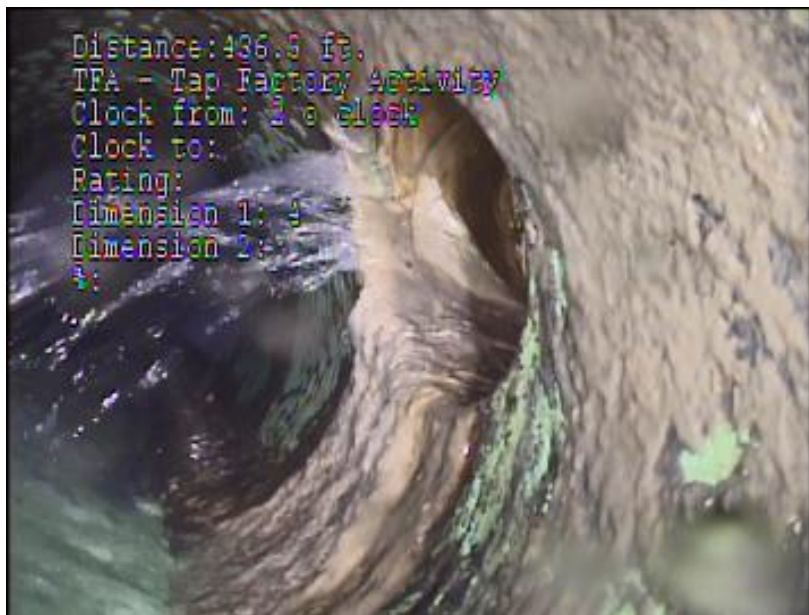
GPS location: (48.993193, -122.259754)

SITE 2: Separation of **PVC pipe (3 inch)** from main **PVC Sewer Pipe (8 inch)** connection between Lawson St. SSMH-2B and Lawson St. SSMH-2. Crack is 39 feet west of Lawson St. SSMH-2B.

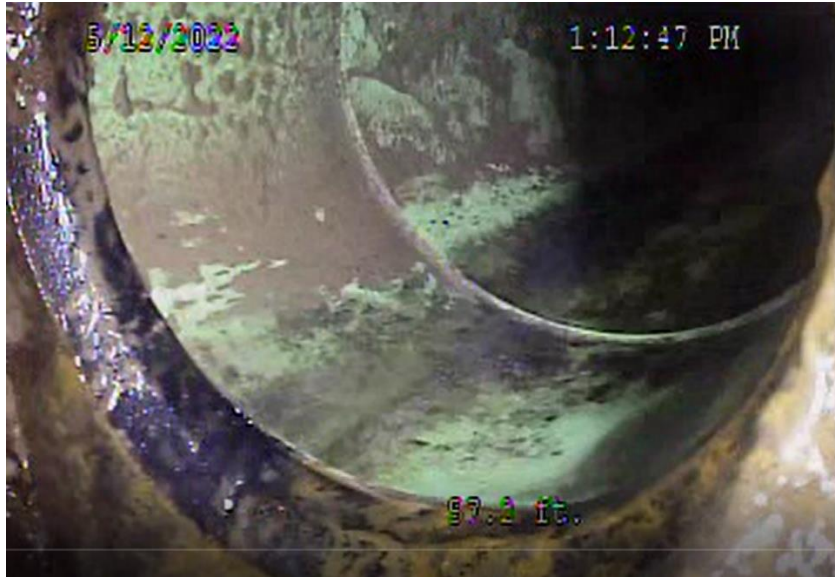
GPS location: (48.994072, -122.260871)

SITE 3: Separation of **PVC pipe (3 inch)** from main **Asbestos Cement Sewer Pipe (8 inch)** connection between Lawson St. SSMH-2B and Lawson St. SSMH-2. Crack is 39 feet west of Lawson St. SSMH-2B.

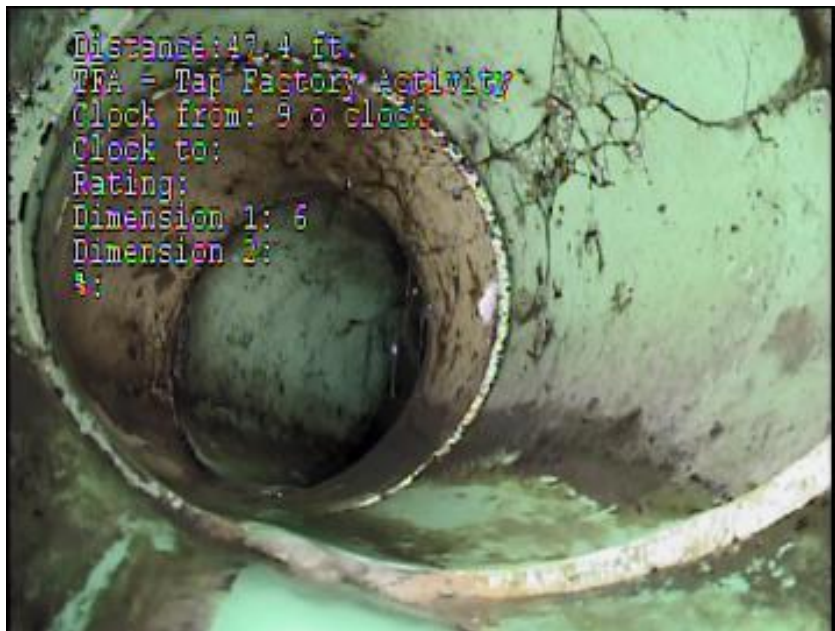
GPS location: (48.992803, -122.260628)

SITE 4: Crack in Noble St. **PVC pipe (3 inch)**. Crack is 47.4 feet west of Noble St. SSMH-1A.

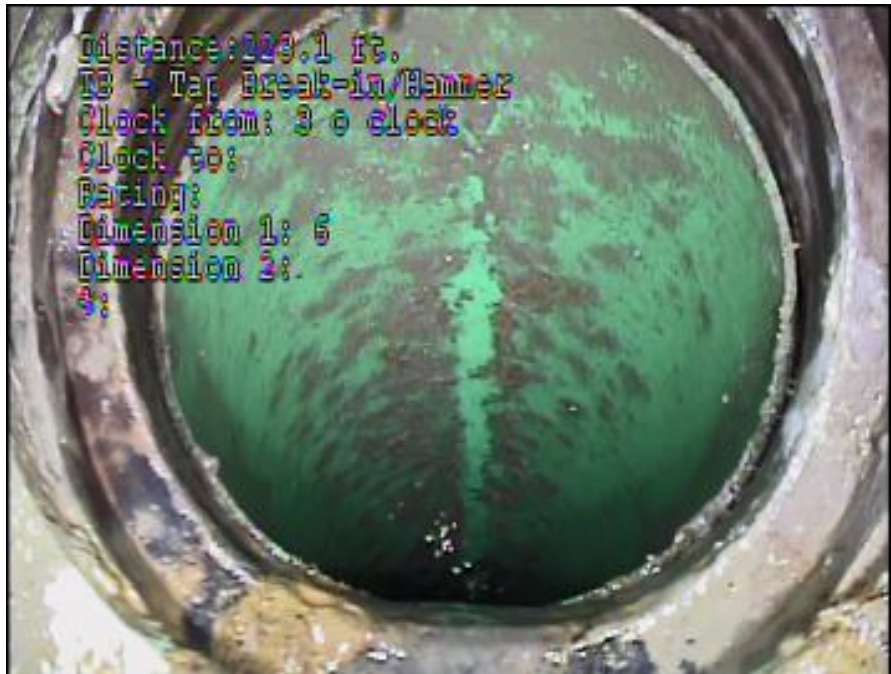
GPS location: (48.994144, -122.256099)

SITE 5: Separation of pipe connection between main PVC Sewer Pipe (8 inch) and PVC house connection pipe (3 inch) under Morton Street. 223 feet west of Morton St. SSMH-3A.

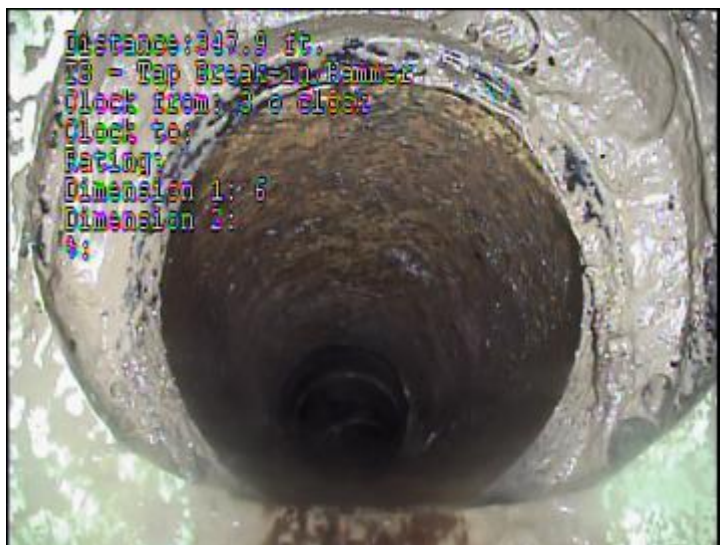
GPS location: (48.994140, -122.256590)

SITE 6: Separation of pipe connection between main PVC Sewer Pipe (8 inch) and PVC house connection pipe (3 inch) under Morton Street. 347 feet west of Morton St. SSMH-3A.

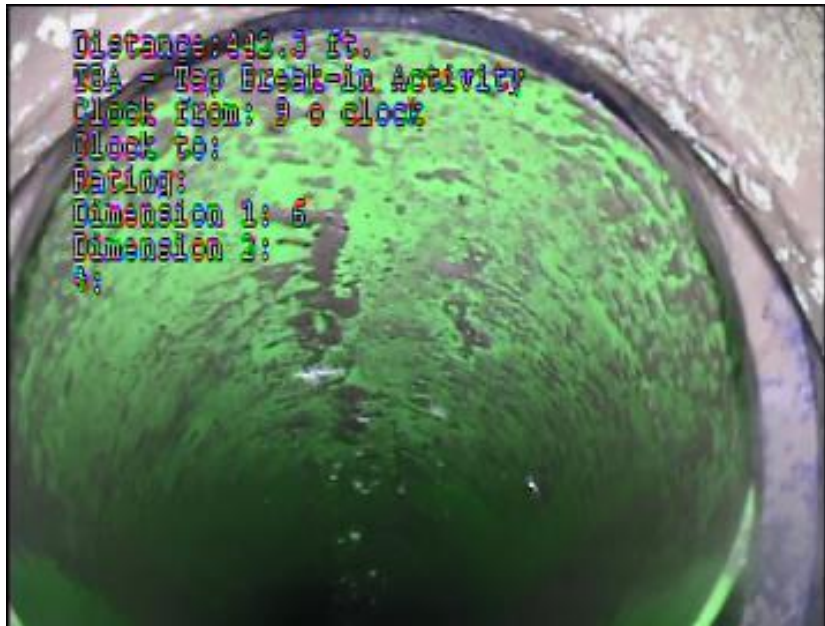
GPS location: (48.994468, -122.258478)

SITE 7: Separation of pipe connection between main PVC Sewer Pipe (8 inch) and PVC house connection pipe (3 inch) under Morton Street. 442 feet west of Morton St. SSMH-4.

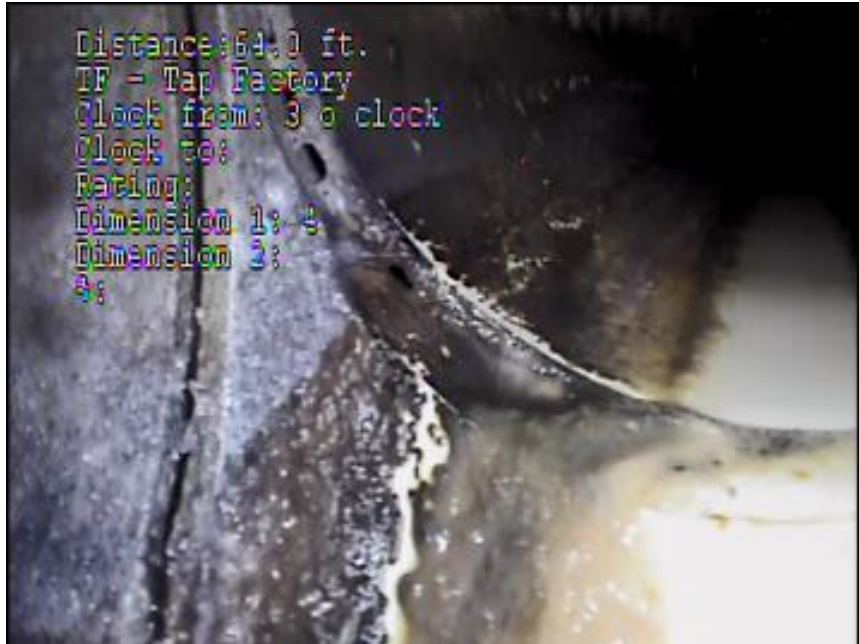
GPS location: (48.991879, -122.262991)

SITE 8: Separation of pipe connection between main PVC Sewer Pipe (8 inch) and PVC house connection pipe (3 inch) under a side street. 64 feet north of Sumas Ave SSMH-2.

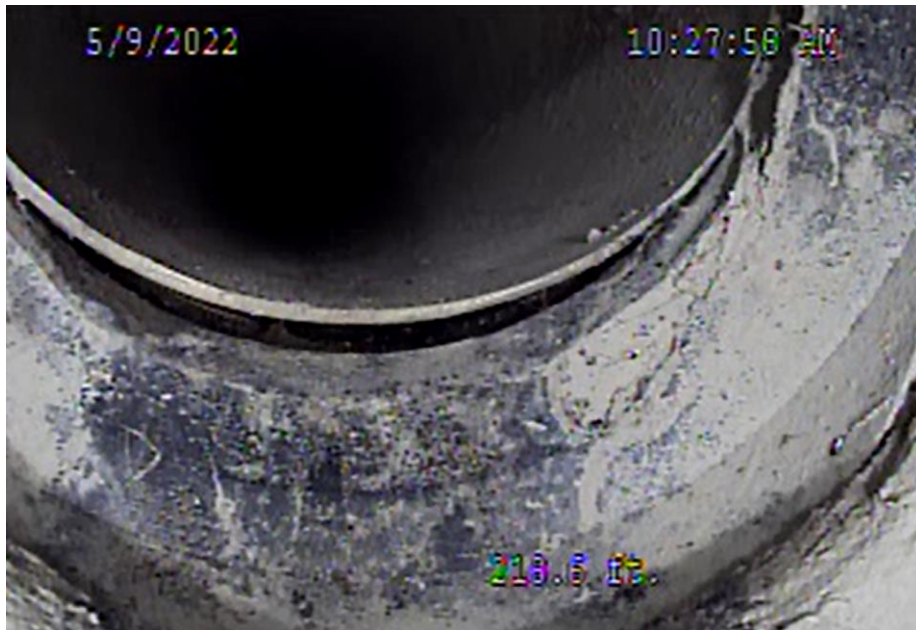
GPS location: (48.993177, -122.263591)

SITE 9: Separation of pipe connection between main **Asbestos Concrete Sewer Pipe (8 inch)** and PVC house connection pipe (3 inch) under a side street. 218 feet east of Sumas Ave SSMH-4A.

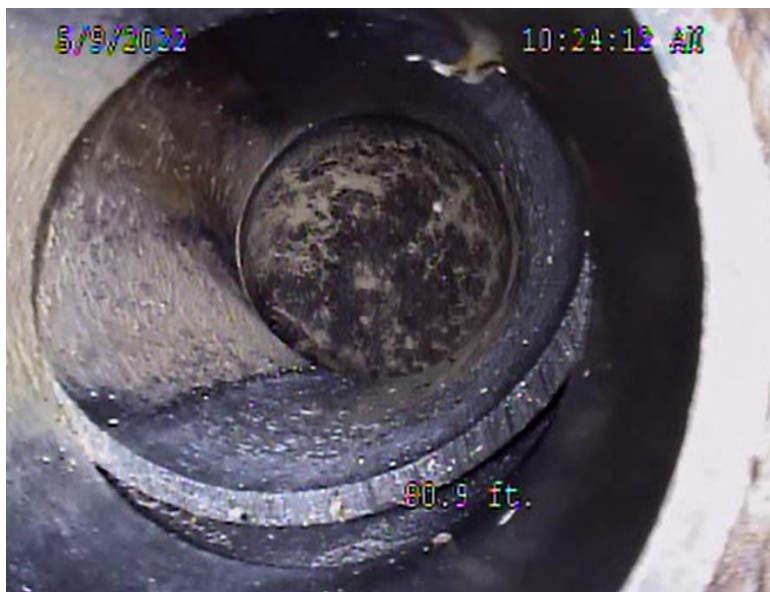
GPS location: (48.993169, -122.264186)

SITE 10: Separation of **PCV Sewer Pipe (3 inch)** under Sumas Ave. 80 feet east of Sumas Ave SSMH-4A.

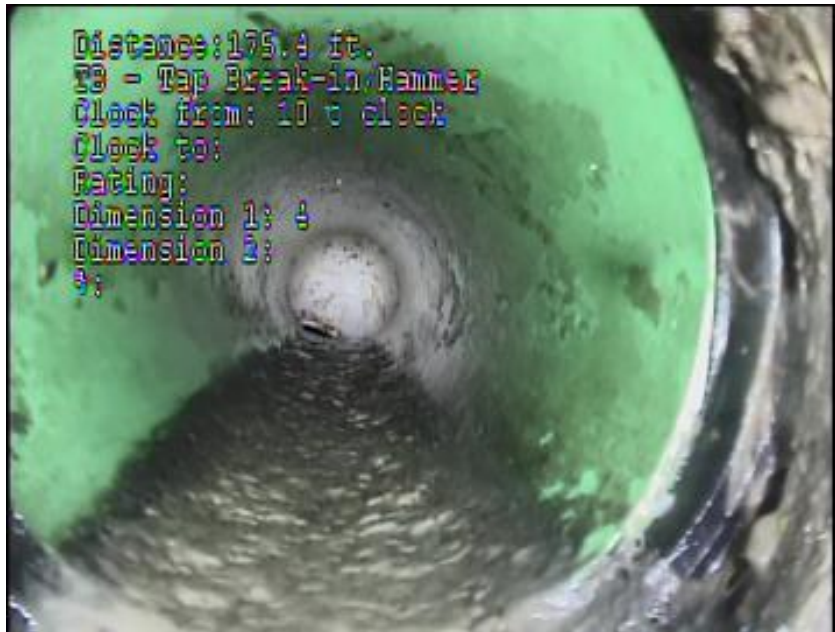
GPS location: (48.996389, -122.260856)

SITE 11: Separation of pipe connection between main **Asbestos Concrete Sewer Pipe (8 inch)** and PVC house connection pipe (3 inch) under Columbia St. Separation 175 feet east of SSMH Columbia 1.

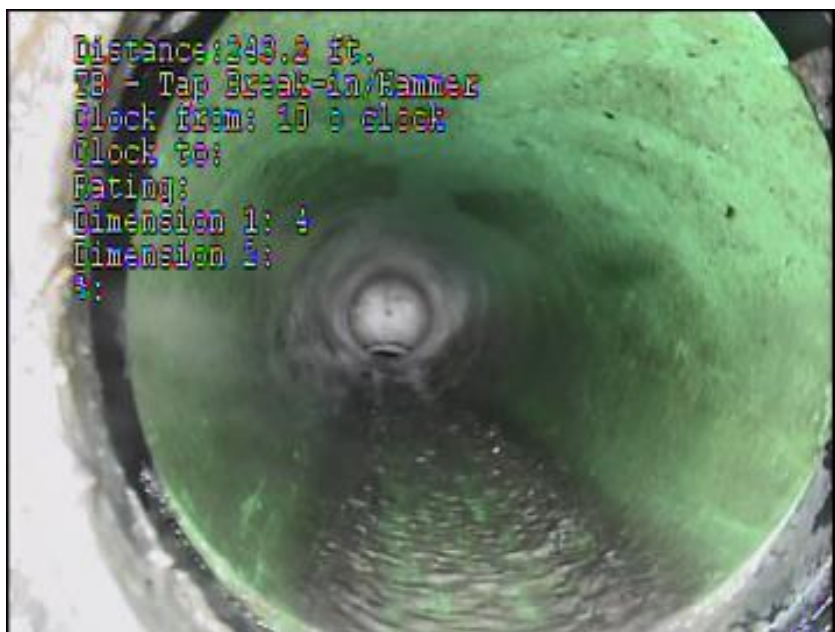
GPS location: (48.996389, -122.260581)

SITE 12: Separation of pipe connection between main **Asbestos Concrete Sewer Pipe (8 inch)** and PVC house connection pipe (3 inch) under Columbia St. Separation 243 feet east of SSMH Columbia 1.

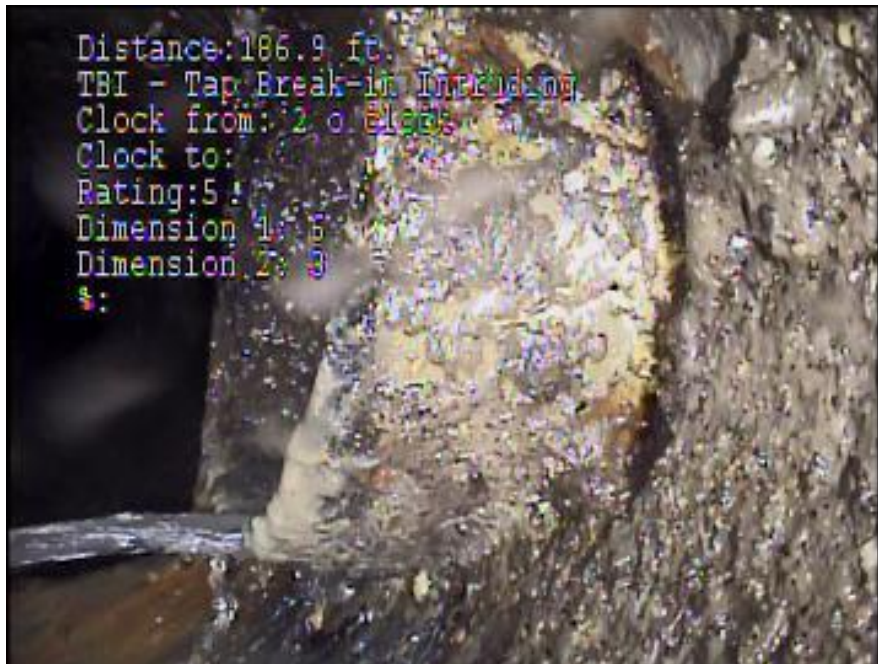
GPS location: (49.000012, -122.263592)

SITE 13: Side asbestos concrete (3 inch) side connection pipe shoved into main asbestos concrete Sewer Pipe (8 inch). 186 feet east of Garfield SSMH-2 under Garfield St.

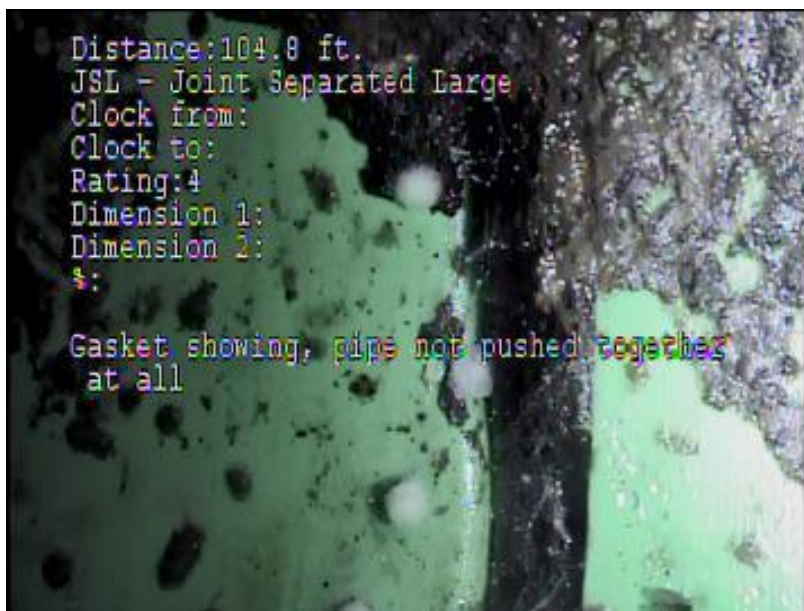
GPS location: (48.999973, -122.258663)

SITE 14: Main PVC pipe separated at joint. Between Garfield SSMH-6A and Garfield SSMH-6. 104 feet west of Garfield SSMH-6A.

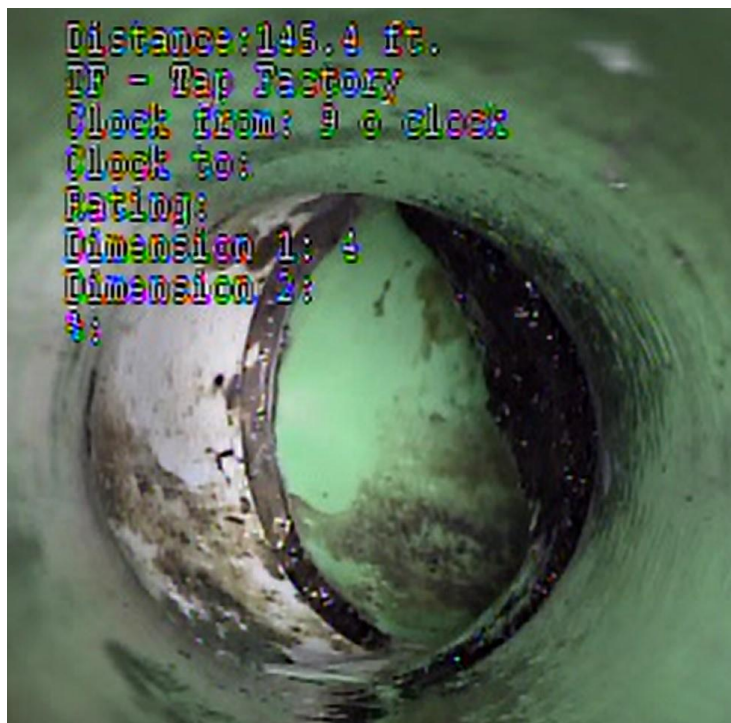
GPS location: (48.999938, -122.253518)

SITE 15: Sideline PVC pipe (3 inch) separated at joint. Between Wilson SSMH-5 and Garfield SSMH-10. 143 feet west of Wilson SSMH-5.

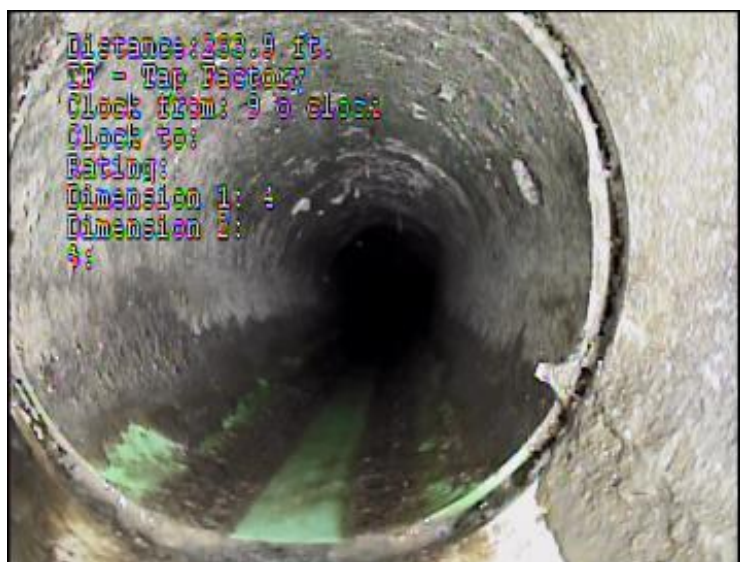
GPS location: (48.999991, -122.254408)

SITE 16: Separation of pipe connection between main **PVC Sewer Pipe (8 inch)** and PVC house connection pipe (3 inch) between Garfield SSMH-10 and Wilson SSMH-5. Separation 232 feet west of Garfield SSMH-10.

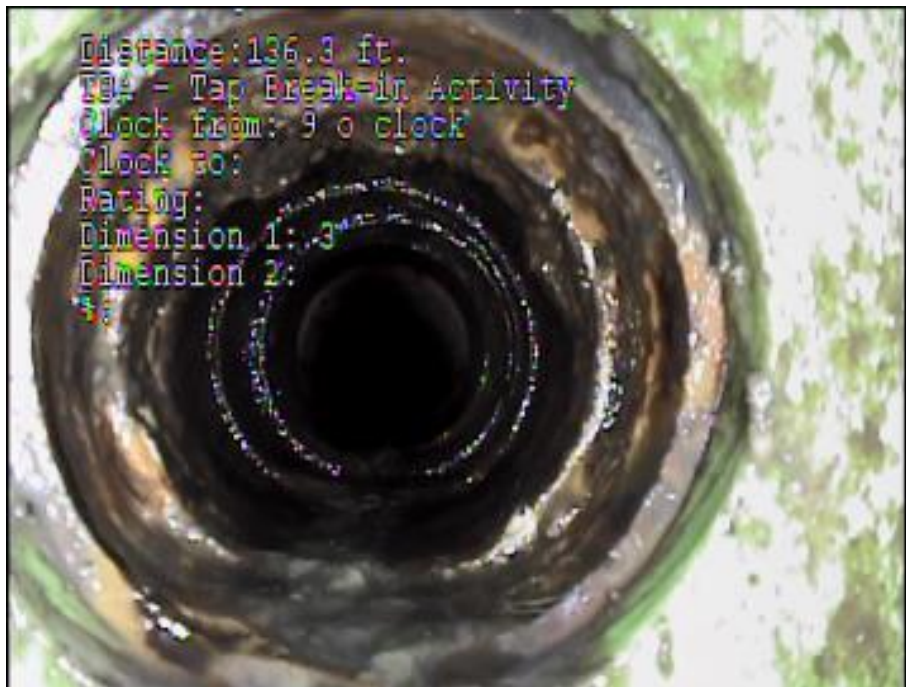
GPS location: (49.000348, -122.268330)

SITE 17: Separation of joint connection between main PVC sewer (8-inch) pipe and the 2-inch iron side pipe. Separation is 136 feet north of Berker SSMH-2.

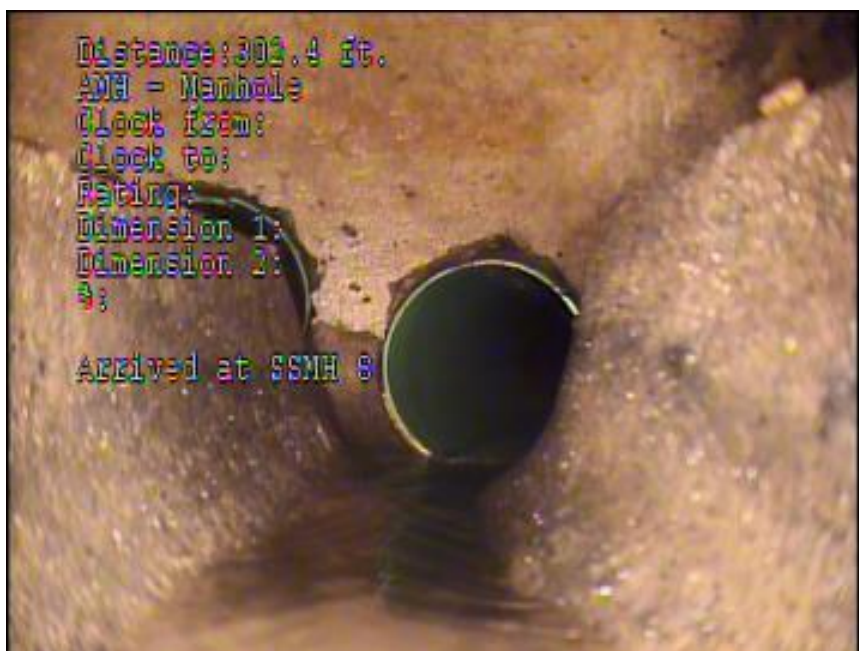
GPS location: (48.998318, -122.270849)

- Site 1: 48.998318, -122.270849:
 - Manhole trough, 1 each of Manhole Trough, misaligned from pipe connection.
- Site 2: 48.995777, -122.272226:
 - Pipes, 1 each of 8-inch PVC Main Sewer Pipe.

SITE 18: Damage to SSMH-8, where the manhole trough has been misaligned from the pipe connection.

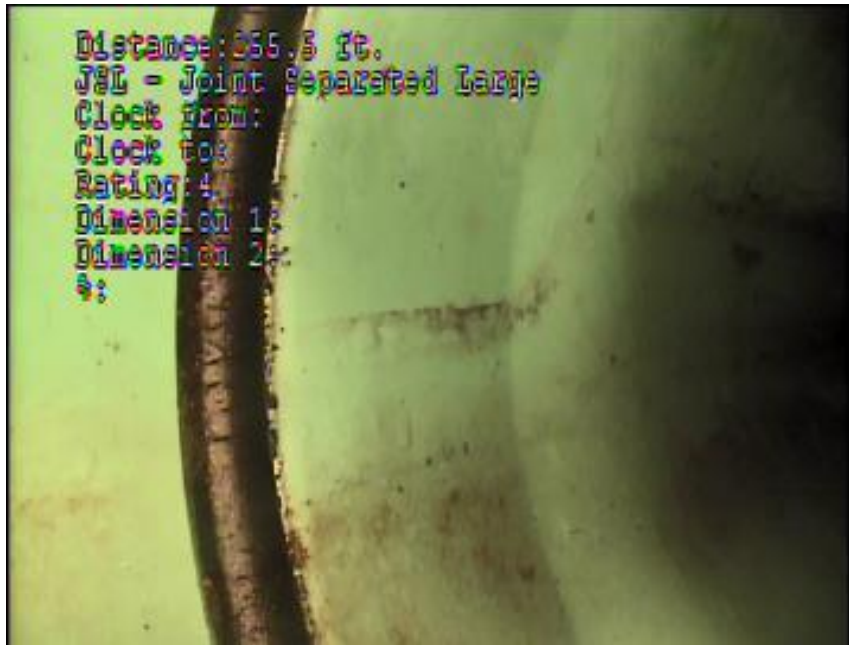
GPS location: (48.995777, -122.272226)

SITE 19: Main PVC pipe separated at joint. Between Bob Mitchell SSMH-3 and Bob Mitchell SSMH-4. 255 feet north of Bob Mitchell SSMH-3.

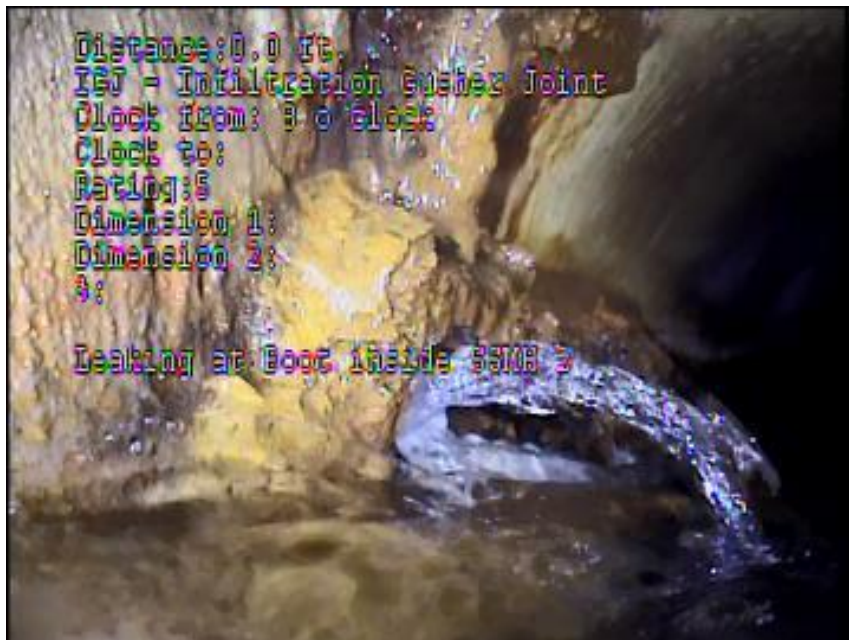
GPS location: (48.992587, -122.272730)

- 48.992587, -122.272730:
 - Pipes, 1 each of PVC 8-inch PVC Main Sewer Pipe, leaking at joint.

SITE 20: Leaking at joint connection between 8-inch PVC sewer main line and EPL SSMH-2.

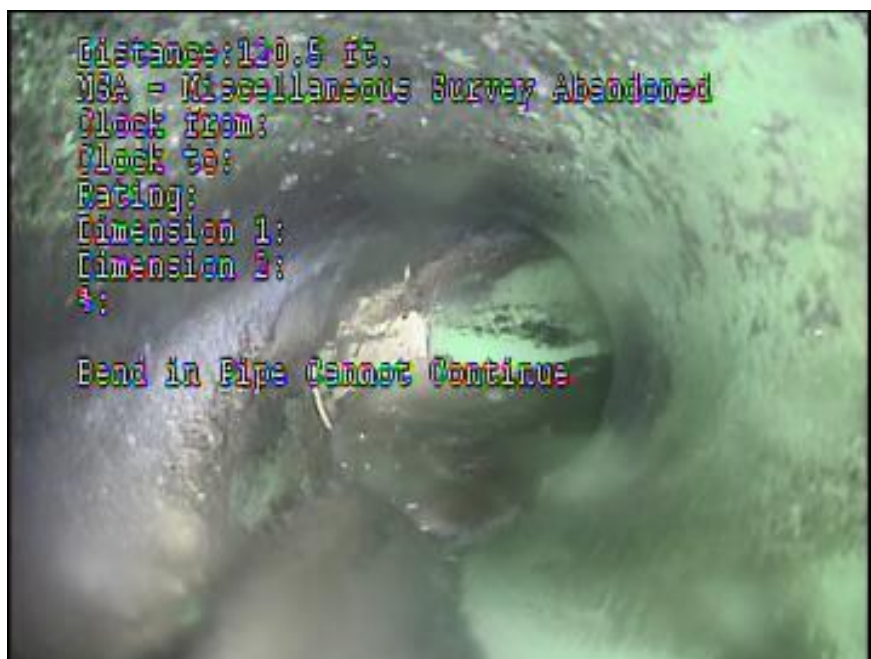
GPS location: (48.998764, -122.268233)

- 48.998764, -122.268233:
 - Pipes, 1 each of 8-inch PVC Main Sewer Pipe, broken/bent by surface water flooding and sewer back up, 0% work completed.

SITE 21: Brake/bend in pipe between Johnson SSMH-1 and Johnson SSMH-2. The bend is 120 feet south of Johnson SSMH-1.

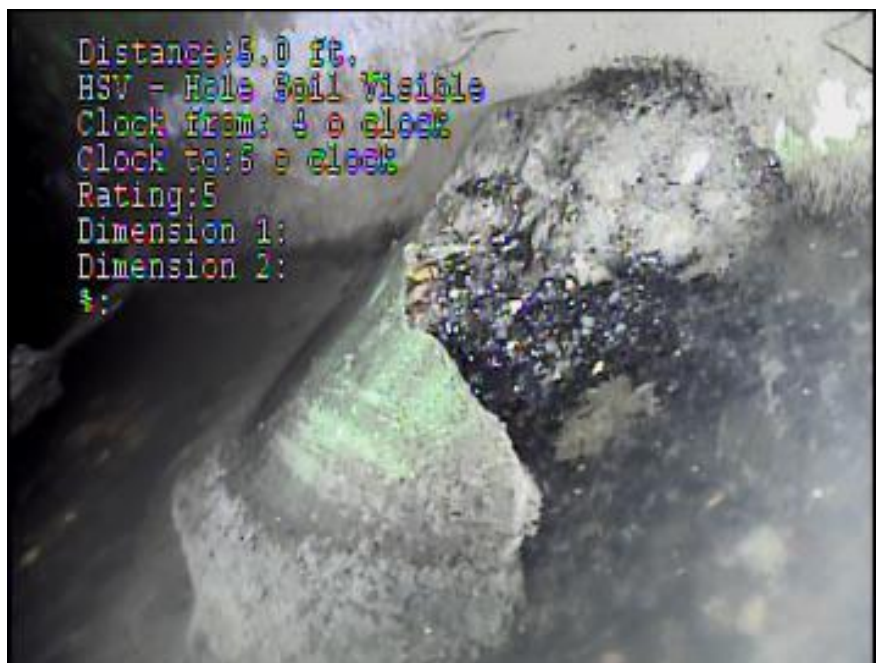
GPS location: (48.992619, -122.281351)

SITE 22: Break in 8-inch PVC sewer main pipe. 5 feet east of W Front SSMH-5.

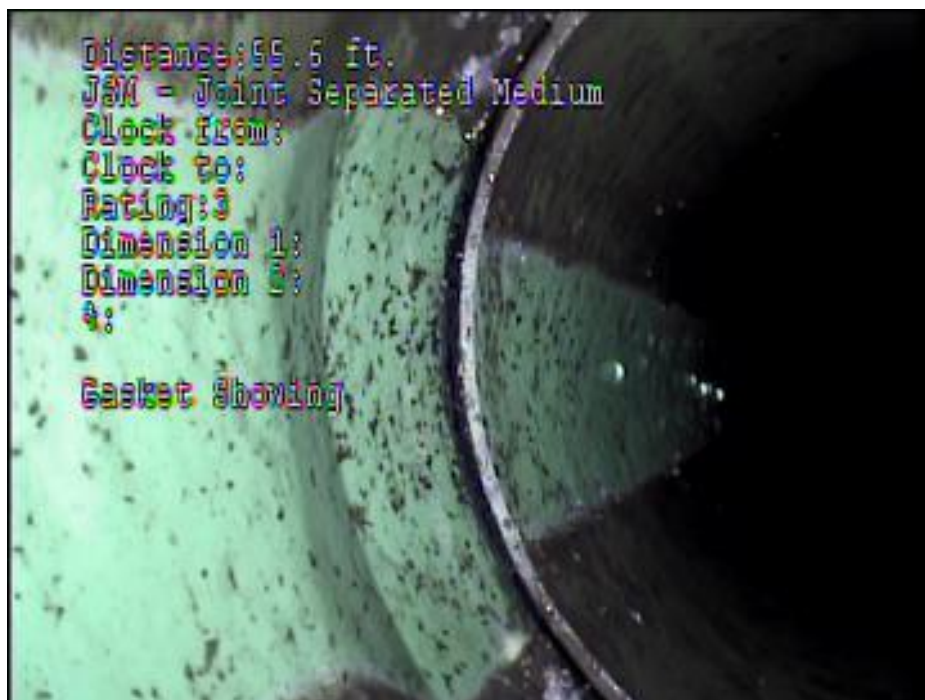
SITE 23: Separation of joint in 8-inch PVC sewer main line between W Front SSMH-5 and W Front SSMH-6. Separation located 55 feet east of W Front SSMH-5.

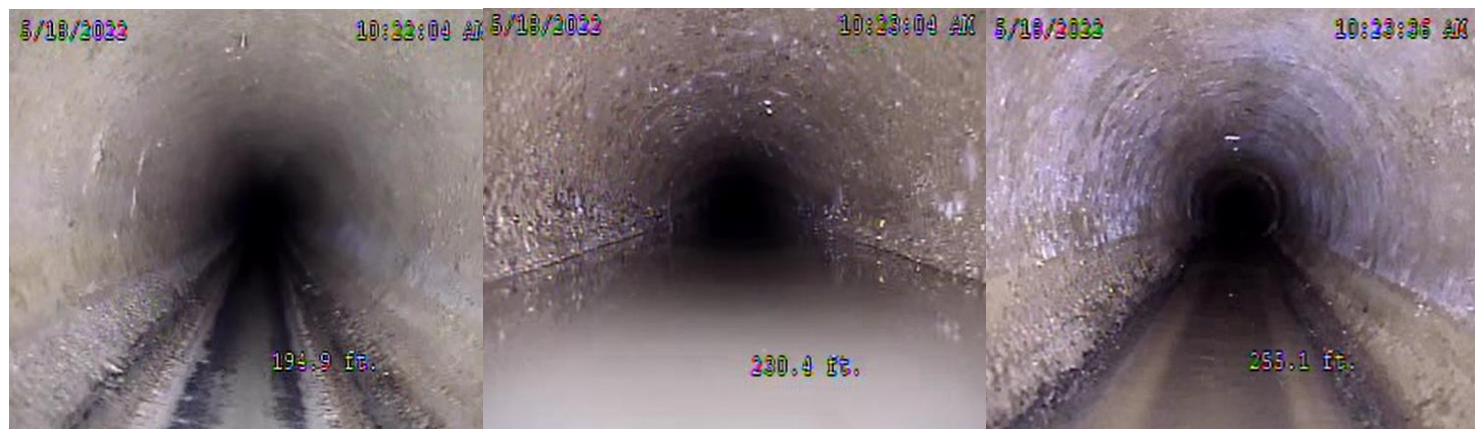
GPS location: (49.001380, -122.260447)

- 49.001380, -122.260447:
 - Pipes, 1 each of Asbestos cement sewer pipe, 60 FT long x 8 IN in diameter, 3-inch deflection.

SITE 24: Deep ~ 3-inch deflection in 8-inch Asbestos Concrete Sewer Pipe between Cleveland SSMH-5 and Lawson SSMH-4. Deflection is approximately 60 feet long and located 194 feet north of Cleveland SSMH-5.

5. The asbestos concrete pipe will be removed by a licensed professional and disposed of to a facility licensed to handle asbestos. All documentation will be required by Contractor per each site.

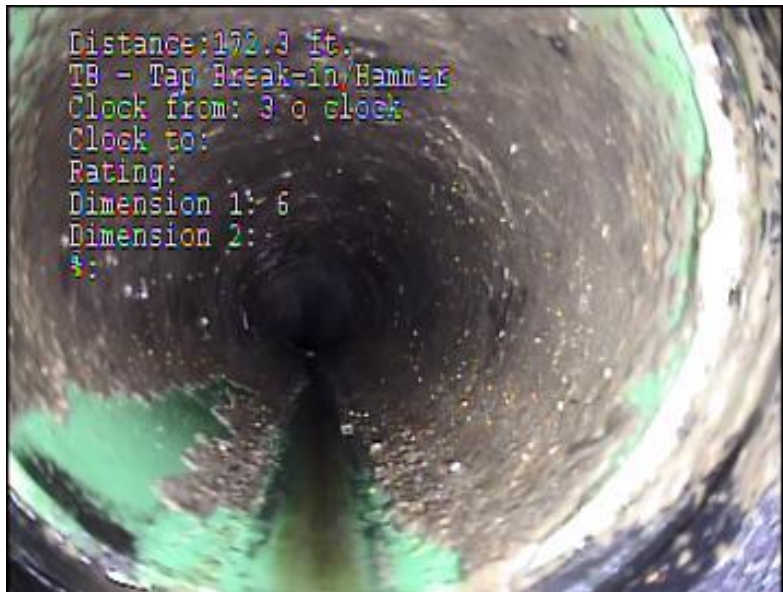
GPS location: (48.999171, -122.264829)

- 48.999171, -122.264829:
 - Pipes, 1 each of Side Service Sewer Connection PVC Pipe (3 inch) to Main Asbestos Cement Sewer Pipe (8 inch), separation.

SITE 25: Separation of pipe connection between main **Asbestos Concrete Sewer Pipe (8 inch)** and PVC house connection pipe (3 inch) under First Street. Separation is 172 feet east of First Street SSMH-1.

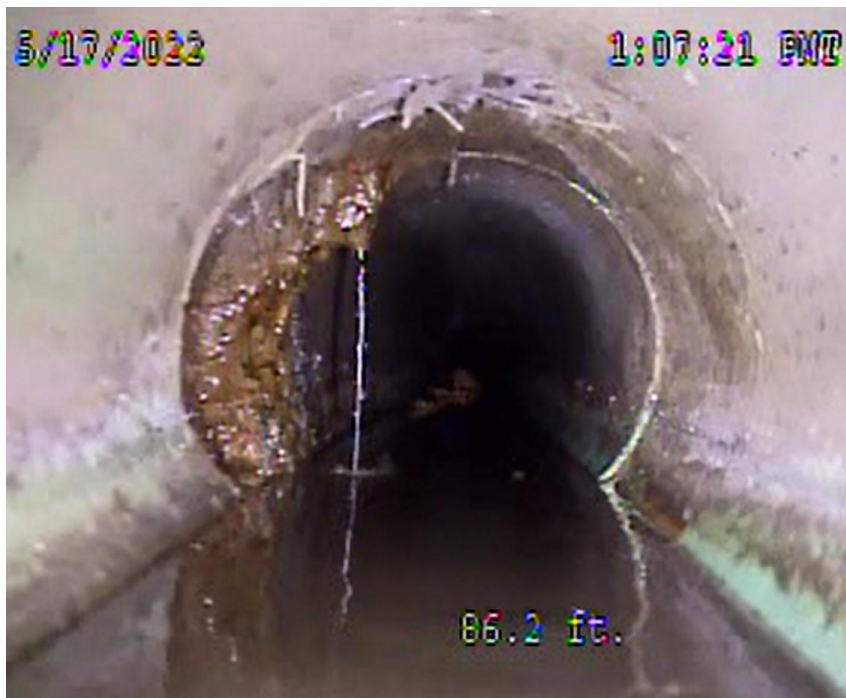
GPS location: (48.998281, -122.259197)

SITE 26: Leaking pipe joint on main PVC sewer pipe (8 inch). 88 feet west of Second St SSMH-7.

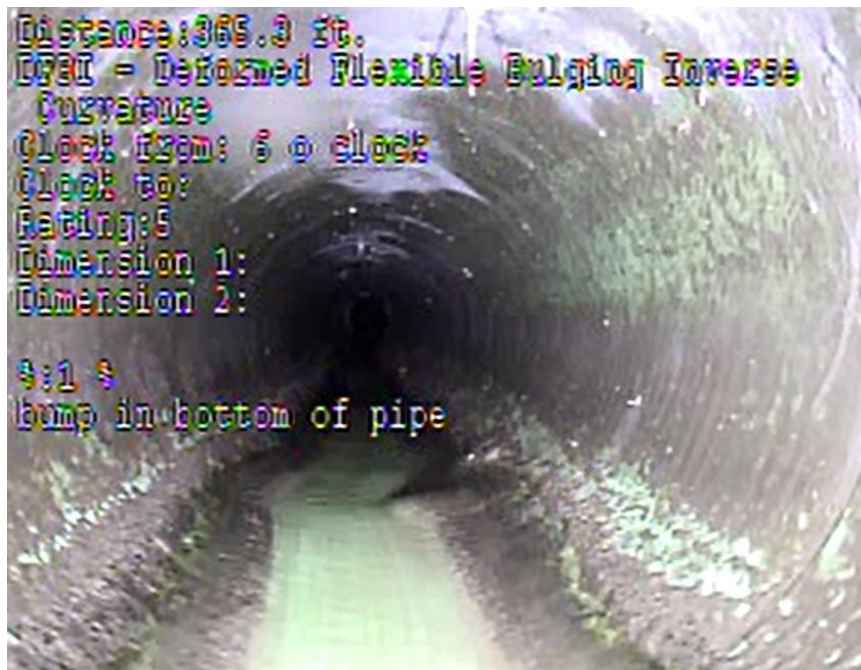
GPS location: (48.998280, -122.258831)

SITE 27: Deflections in main PVC sewer pipe (8 inch) under Second Street. 11 feet east of Second St SSMH-7.

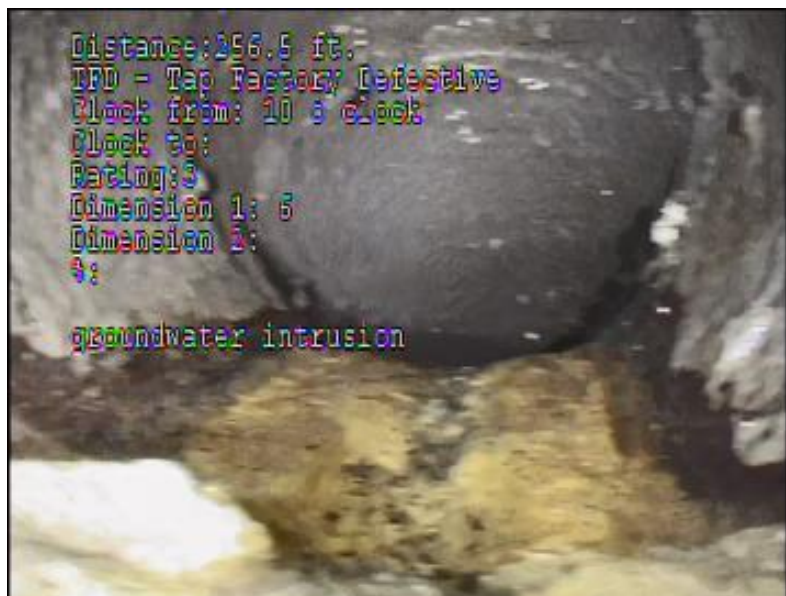
GPS location: (48.998258, -122.264458)

SITE 28: Separation of joint between 8-inch Asbestos Concrete sewer main and 4-inch Cast Iron side sewer pipe under Second St. Separation is 41 feet west of Second St SSMH-3.
